Thermal shock resistance level with mechanical constraints

The executed tests show that VENUS, moulded in PMMA, passed the thermal stress tests without any physical deterioration of the material, up to a temperature of 90°C.

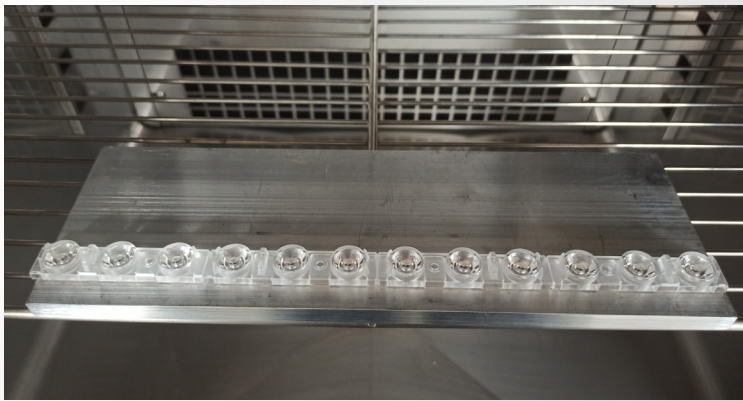
Before starting the tests, a visual inspection was performed in order to check the integrity of the part. The part resulted physically intact. The thermal test was performed at a temperature of 90°C, using the climatic chamber LTH 225°.

Photo: the part in the climatic chamber.

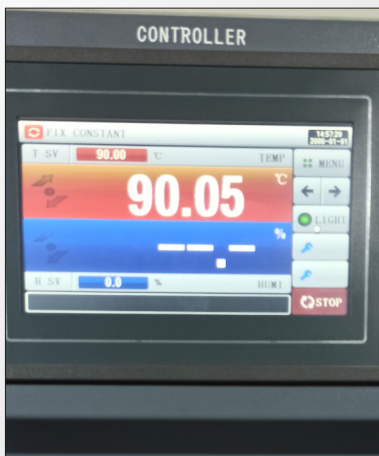
Temperature set in the climatic chamber

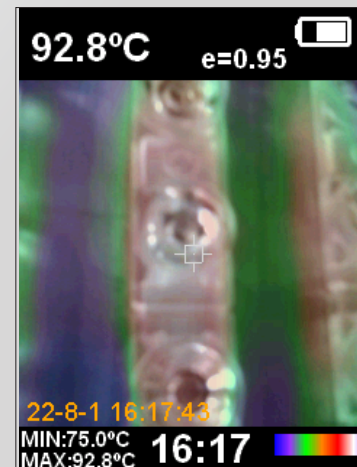
Temperature detected on the part by IR thermal camera

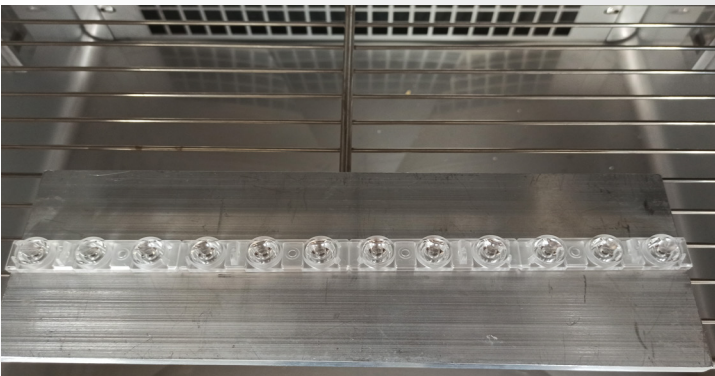
Photo: the part in the climatic chamber after testing.

After testing, a final visual inspection was performed. The result was positive (view photo).
